Cross Laminated Timber

Introduction to Seismic Performance

Seismic Performance of CLT Structures

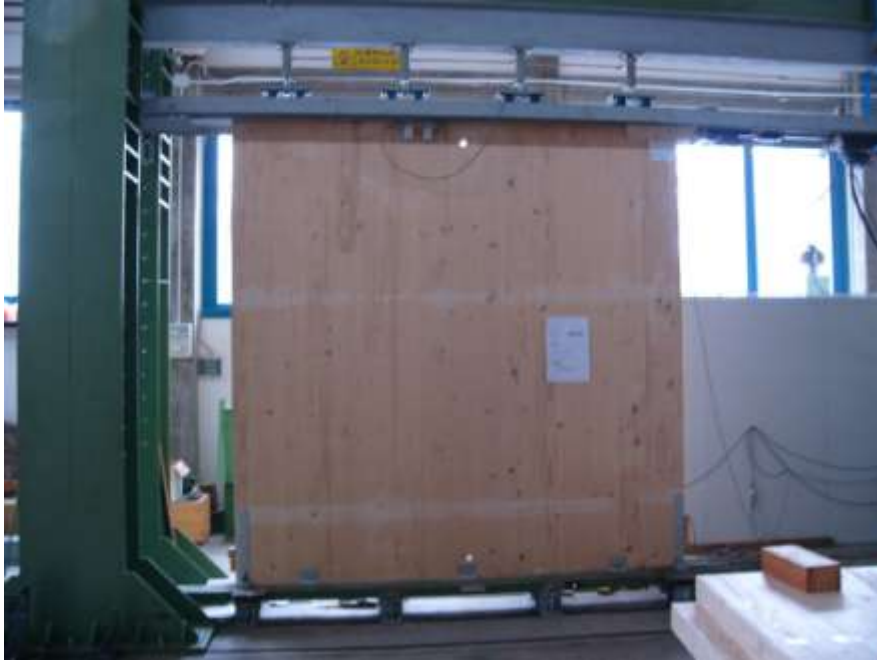
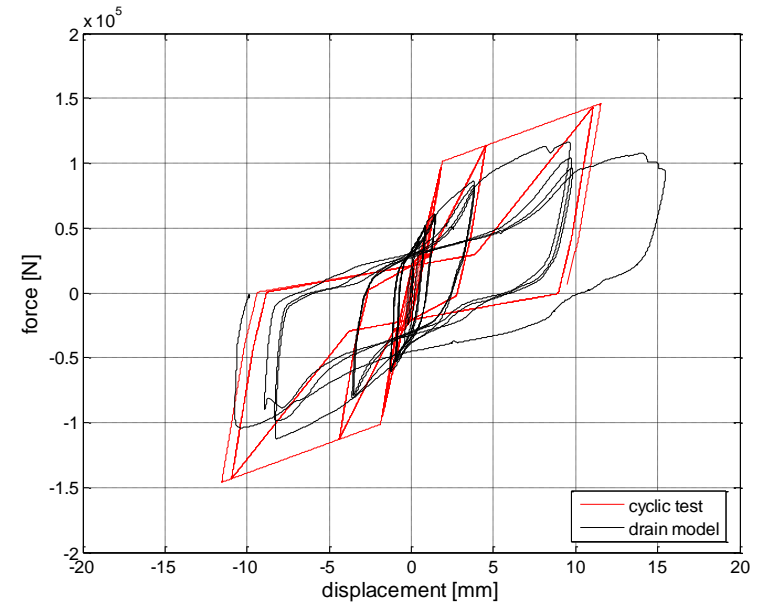
Tests on single walls

- Monotonic and cyclic tests on 3x3m CLT **walls** at IVALSA, Trento, Italy
- Pseudo-dynamic tests on full-scale **1-storey** box-type specimen at University of Trento
- Full-scale shaking table tests on **3-storey** CLT building at NIED, Tsukuba, Japan
- Full-scale shaking table tests on **7-storey** CLT building at E-Defense, Miki, Japan

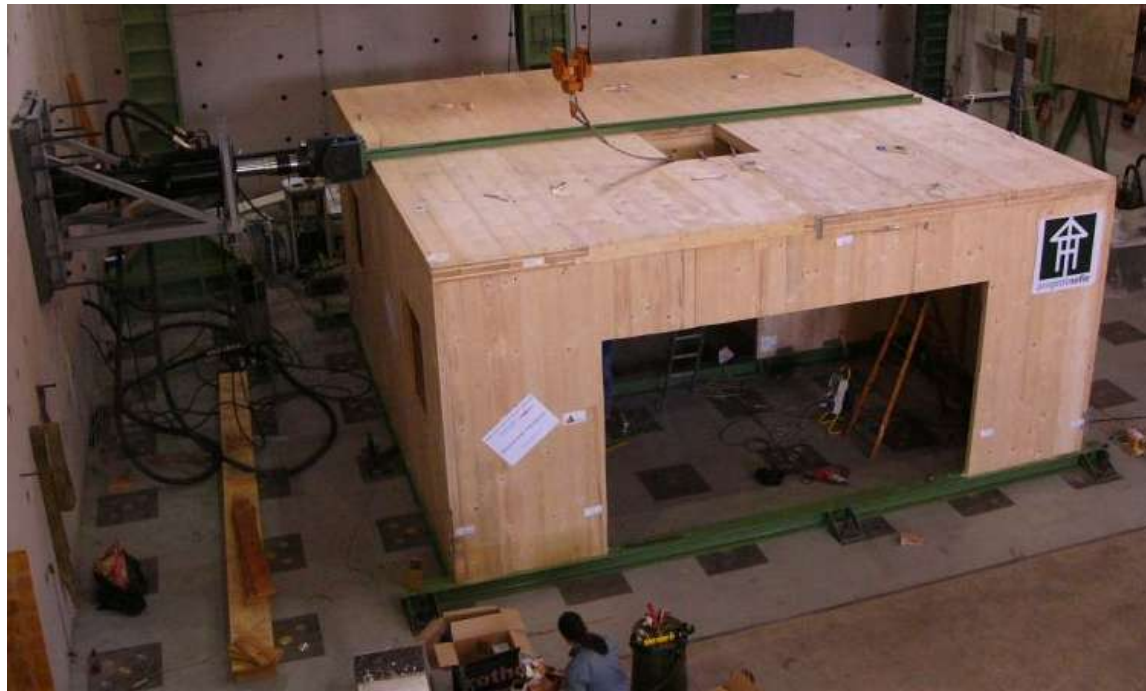
Pseudo-Dynamic Tests on Single Storey Specimens

- 7m x 7m in plan and 3m high
- 3 specimens with different wall configurations
- 2 earthquakes (Kobe and El Centro), 2 intensities (0.15 and 0.5g)

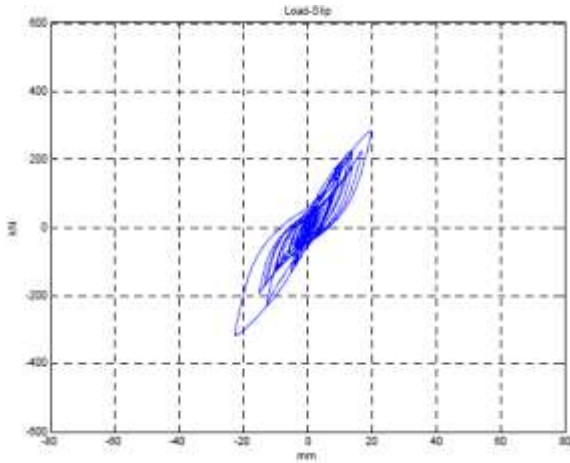
Configuration 1

Load-Displacement Curves for Kobe 0.5g

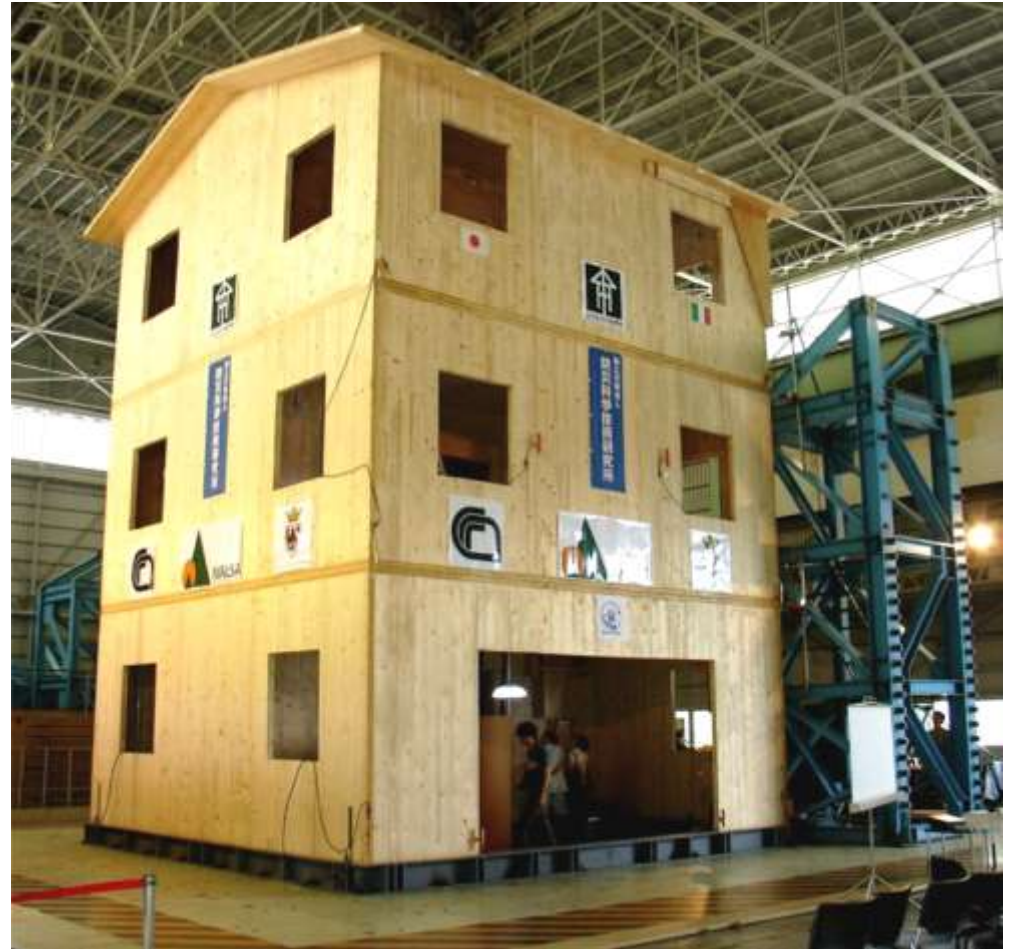
Shaking Table Tests on 3-storey Buildings

- Conducted at NIED Tsukuba
- Building was 7 x 7 m in plan and 10 m high
 - Weight 50t (20t +30t)
 - Walls 85 mm
 - Floors 142 mm
- Designed with $q = 1$
- 3 Earthquakes (0.15 - 1.2g)
 - El Centro
 - Kobe
 - Nocera Umbra
- **Total of 26 tests**
 - 14 tests were $\geq 0.5g$

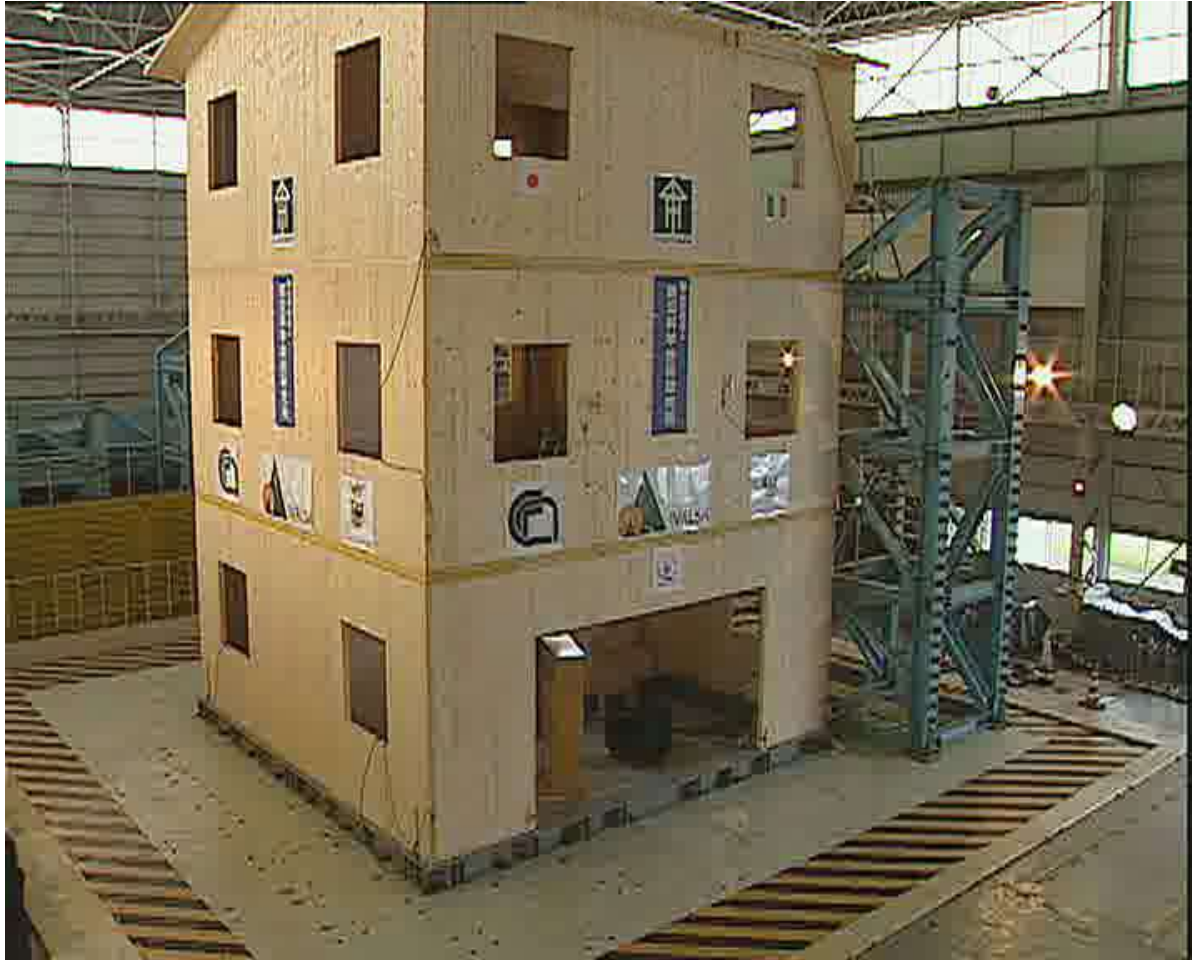
Test Video - Configuration C with Kobe 0.8g

Record	PGA [g]	Restoring intervention (before the test)	Observed damage (after the test)
Nocera Umbra	0.35	Tightening of holdown anchor bolts	None
El Centro	0.50	Tightening of holdown anchor bolts. Replacing of screws in vertical joints between panel	None
Kobe	0.50	Idem	None
Kobe	0.80	Idem	Slight deformation of screws in vertical joints between panels
Kobe	0.50	Idem	None
Kobe	0.50	Tightening of holdown anchor bolts	None
Kobe	0.80	Replacing of holdown anchors and tightening of bolts. Replacing of screws in vertical joints between panel	Slight deformation of screws in vertical joints between panels
Nocera Umbra	1.20	Tightening of holdown anchor bolts. Replacing of screws in vertical joints between panel	Holdown failure and deformation of screws in vertical joints between panels

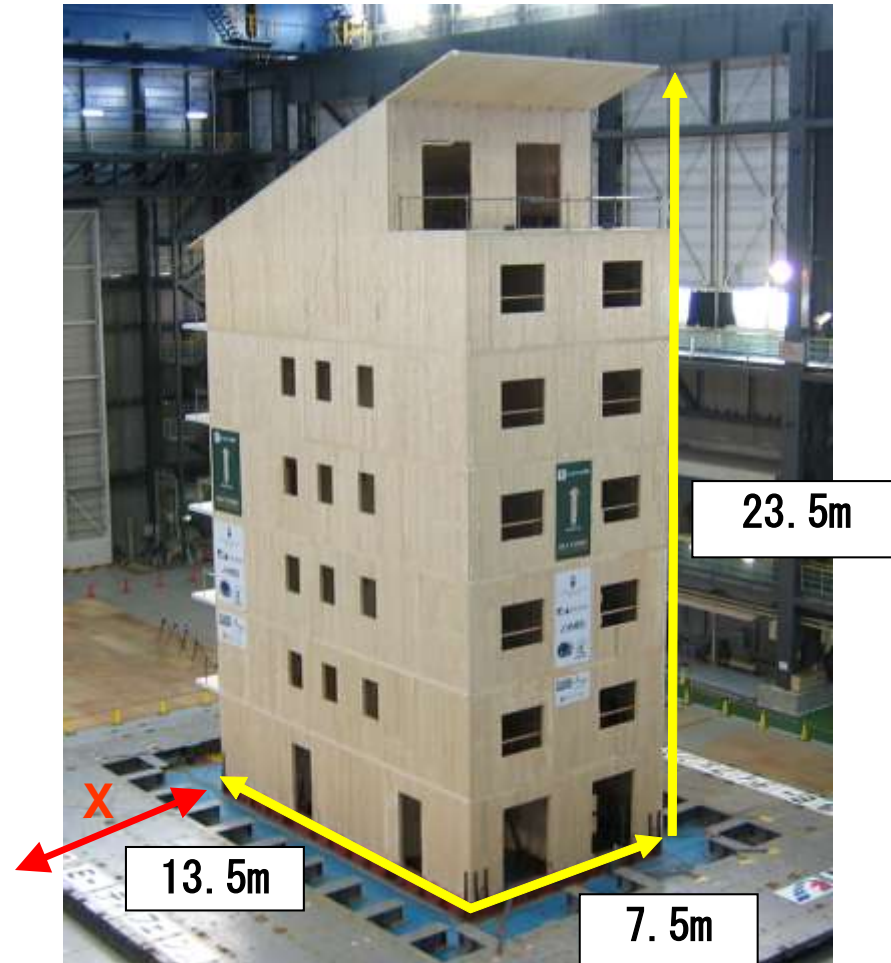
Shaking Table Tests on 7-storey Building

- Conducted at E-Defense in Japan
- Building weight 270t (120t + 150t)
- Wall panel thickness
 - 140 mm floors 1 and 2
 - 125 mm floors 3 and 4
 - 85 mm top 3 floors
 - All floor panels 142 mm
- Wall panels length 2.5 m
- Two 3-axial records used
 - Kashiwazaki Kariwa Quake
 - X (0.3g) Y (0.68g) Z (0.4g)
 - Kobe JMA Quake
 - X (0.6g) Y (0.82g) Z (0.34g)
- **Total of 14 tests**
 - 10 tests were $\geq 0.3g$

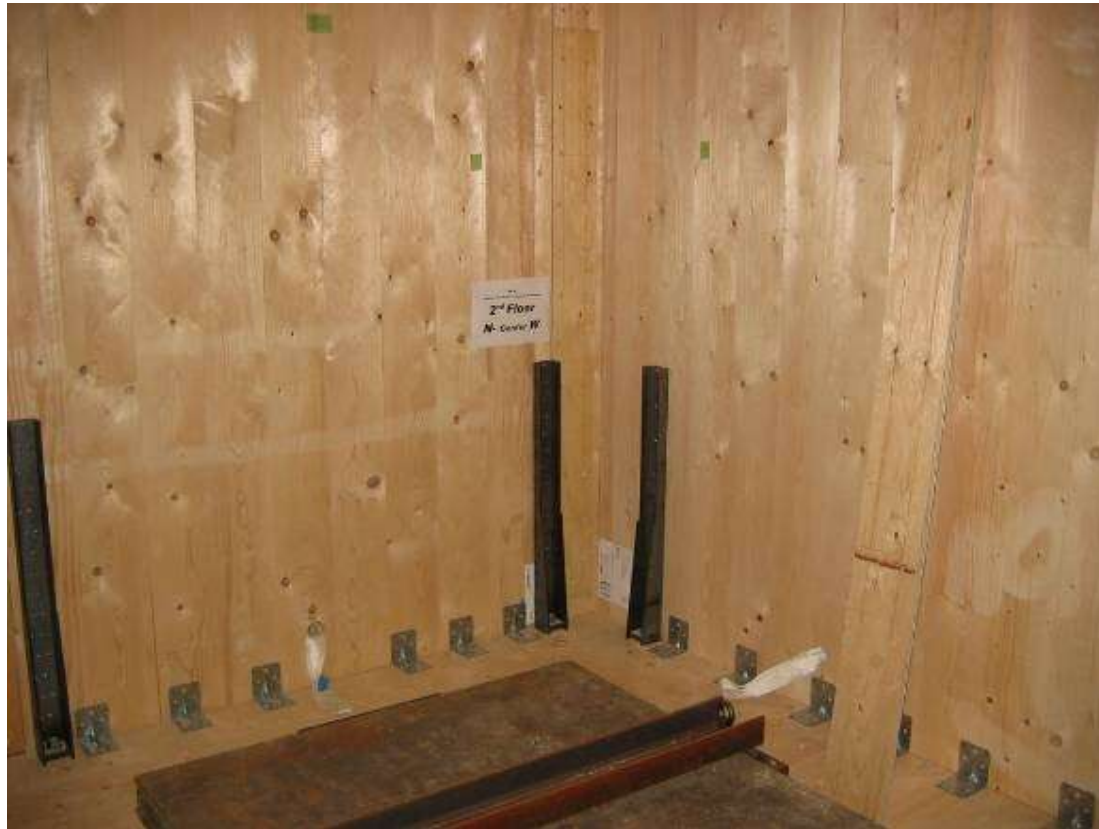
Connecting Devices

- Connectors included steel brackets with screws and custom made hold-downs with screws

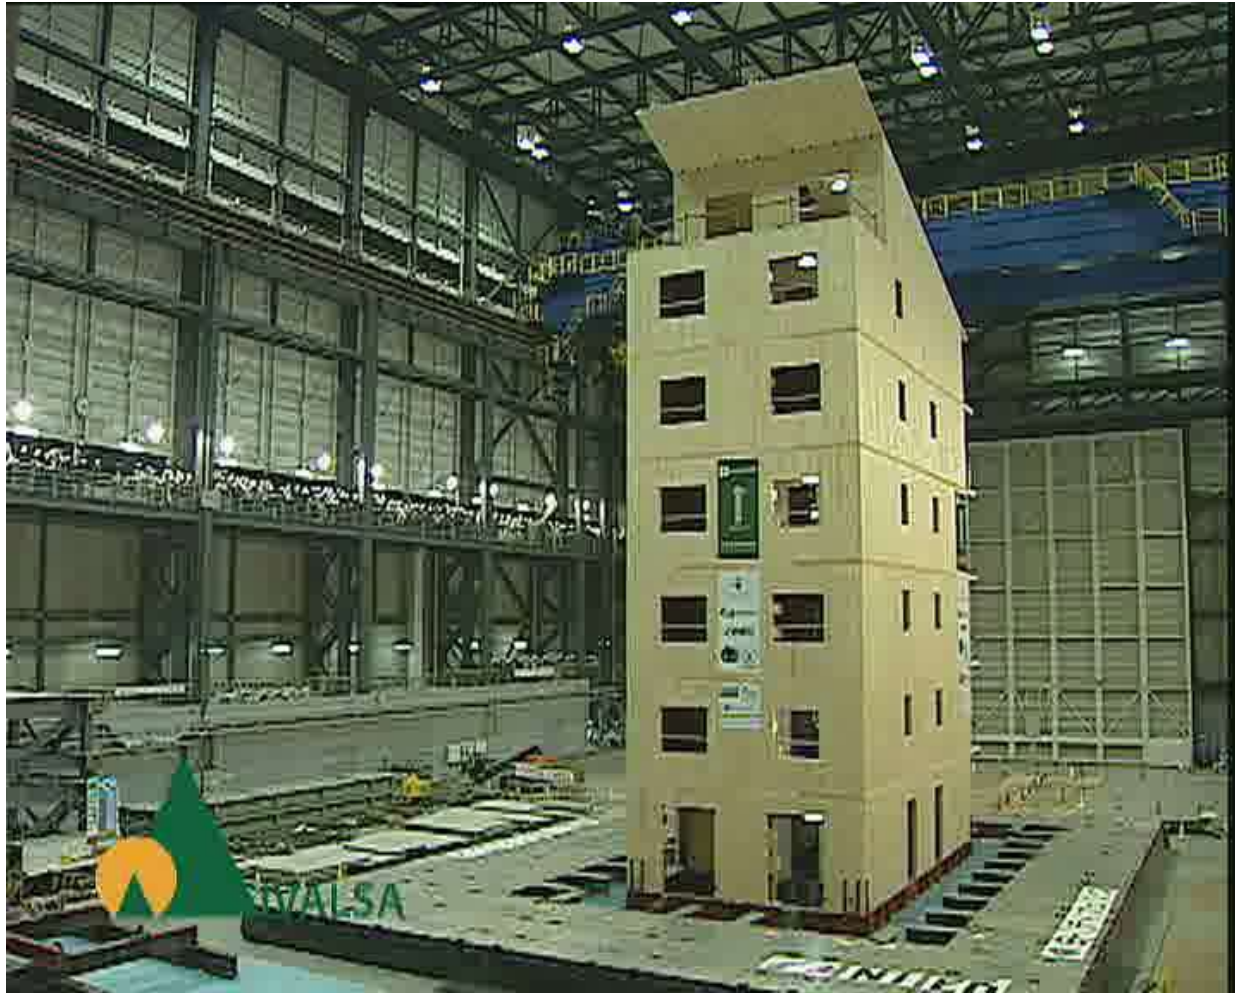
Building Response - Kobe Earthquake 0.82g

- The building showed very good seismic behaviour under all severe earthquake motions
- Max top displacement of 287 mm (X) and 175 mm (Y)
 - Max storey drifts approx 2.4% (X) and 1.6% (Y)
- **The damage after all tests was negligible**
